**QUESTIONNAIRE REPORT ON
HYDROGENERATORS FIRE PROTECTION UPDATE
STUDY OF THE GROUP 1- USERS' ANSWERS
(September 2009)**

Convener: Alexander Gromow (BR)

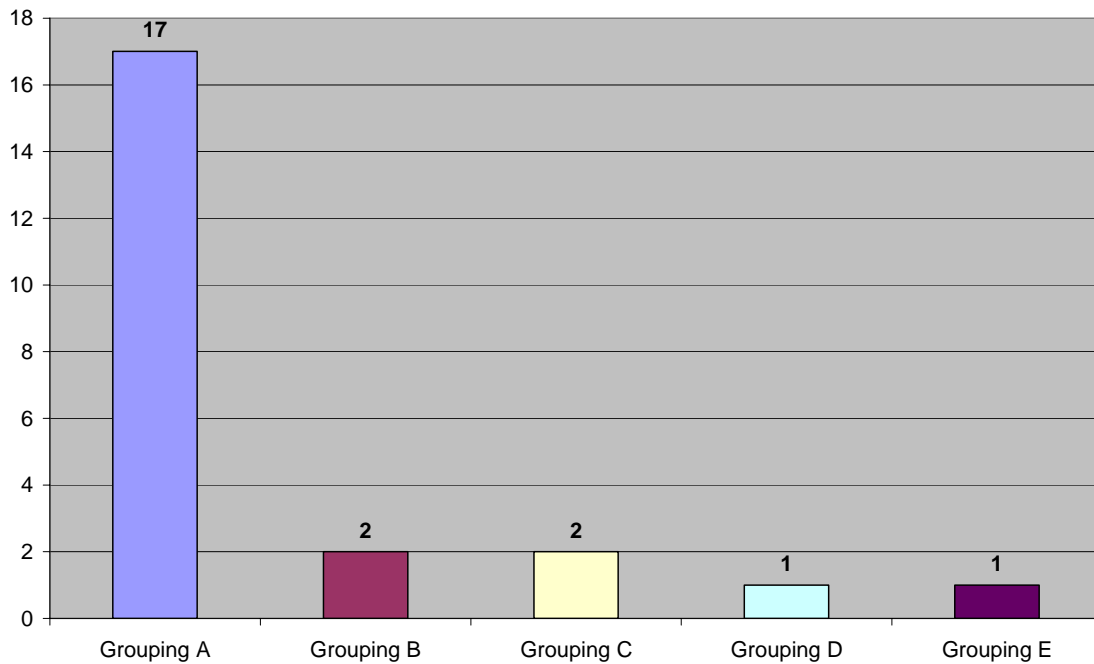
1.5.2.5) Electrical Fault in the stator winding. Additional information:		
Grouping A	Stator winding damage	17
Grouping B	Excitation slip rings and/or brushes damage	2
Grouping C	Rotor and stator winding damage	2
Grouping D	Little damage but great cleaning works.	1
Grouping E	Fire remained contained inside the generator housing	1
Grouping F	Answer does not match the subject asked (not considered for the graphic)	1
Total of additional information given		24

The 17 additional information reaching 70,8% of the total that point to stator winding damage (Grouping A) show that this is the most critical part of the machine and deserves special attention when the GFP's design is made.
